Inspection Report

Mine Name: Eagle Canyon
Operator Name: Georgia Pacific

Permit number: M0150050
Inspection Date: April 11, 2007
Time: 1:00-1:30 PM

M0150050, Eagle Canyon Quarry, Georgia Pacific

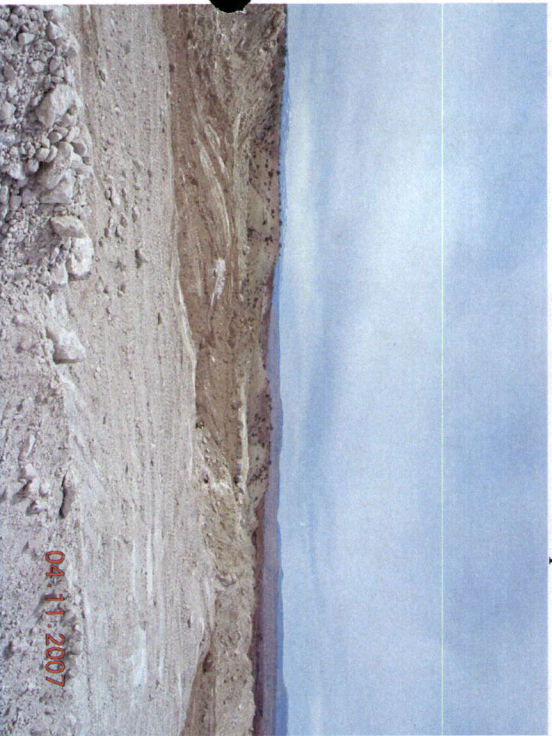
It looked like the operator might have done some reclamation grading on the west side of the mine, but I wasn't sure (Photo 1).

Photo 1. It appeared the operator might have done some grading for concurrent reclamation in this area.

If the operator is doing any reclamation work, even if it is interim, I suggest that the Division and the BLM be contact for suggestions. Certain techniques, such as leaving the surface rough with a lot of rocks, have worked very well at this site and at the nearby Diamond K Mine. There is an area toward the north side of the mine where it appears test plots were installed several years ago. I do not know the details of how this was done, but revegetation in this area has been very successful. As revegetation is done, the operator should use some of the techniques that were used at these plots.

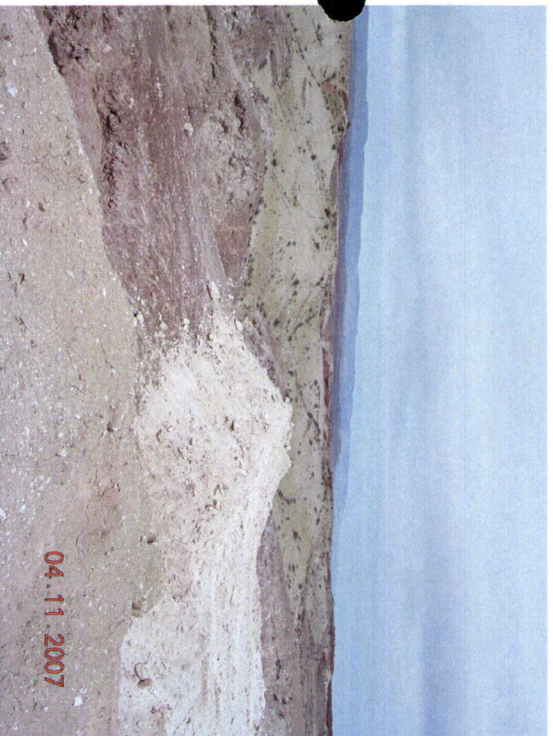
The mine area has been expanded by a few thousand square feet on the west side. I could not tell that any soil was salvaged in this area.

Photo 2. The disturbed area was expanded slightly in this area.

The operator needs to be sure to salvage topsoil in any areas where the disturbed area is expanded. The existing stockpiles need to be maintained, and while signs are not required for the stockpiles, it is good to have them so these piles are not disturbed.

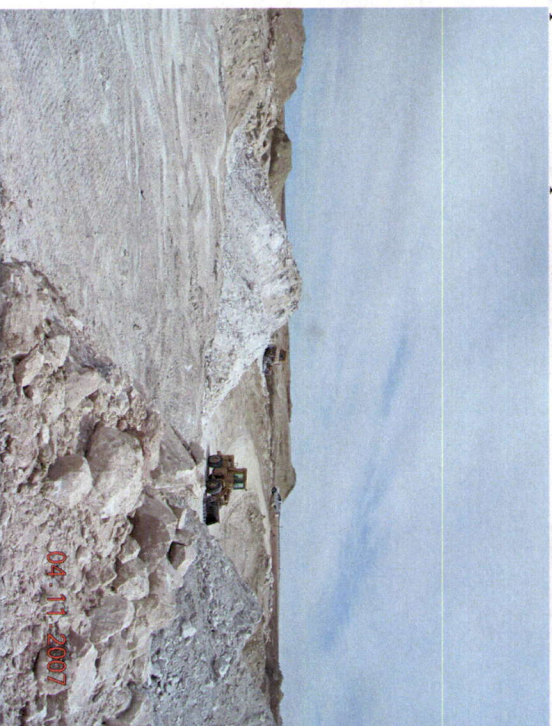
Photo 3. Part of the area where the operator was mining during the inspection.

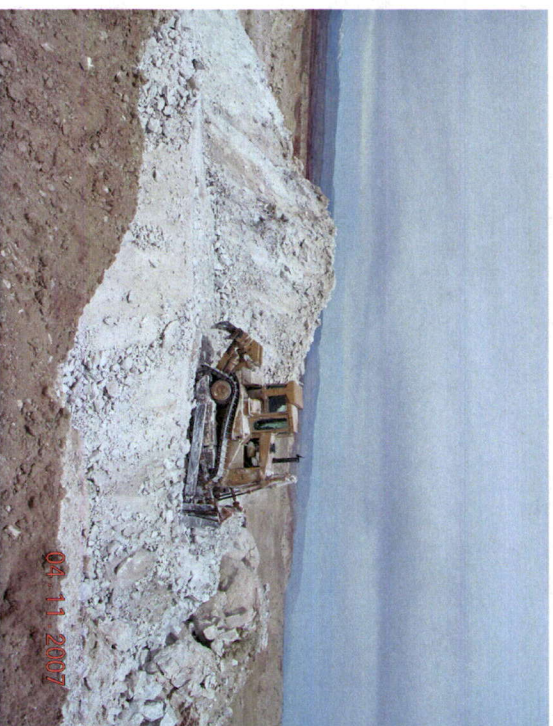
During the inspection, the operator was pushing gypsum into a stockpile, probably in preparation for loading. Since the last inspection, gypsum has been mined from certain areas, and some of these have been regraded as stated above.

Photo 4. Dozer pushing gypsum into a stockpile.
